Australian Nuclear Science & Technology Organisation

Problems with High Voltage During Commissioning of New 2MV Tandatron Accelerator

Presenter: David Button

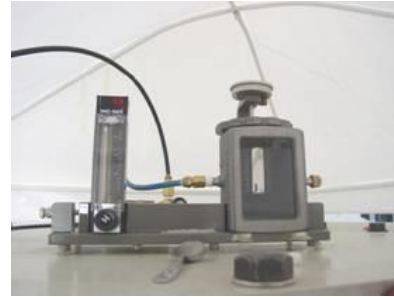
- In line with best practice the SF6 gas was checked and continually dried to achieve a dew point less than -40°C .

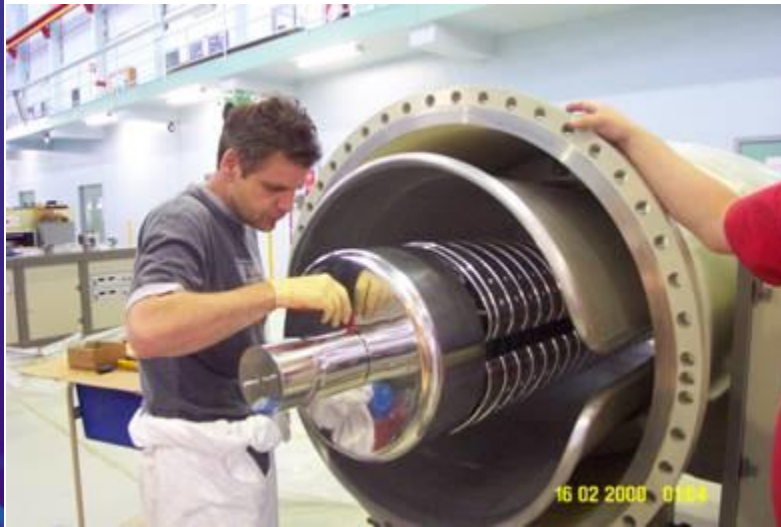
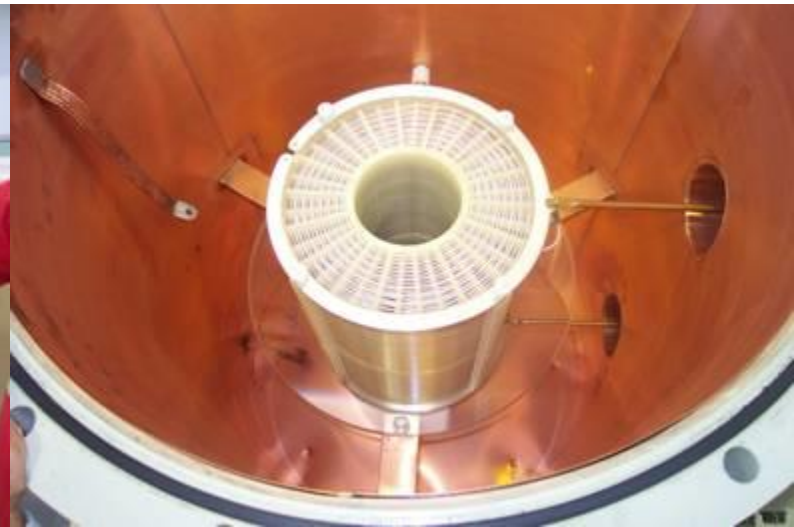
- The Q factor of the driver was tested to check the performance of the coils, capacitive plates, and diode stacks.
- The Q factor should be between 1000 - 1100, we achieved 650 - 700.

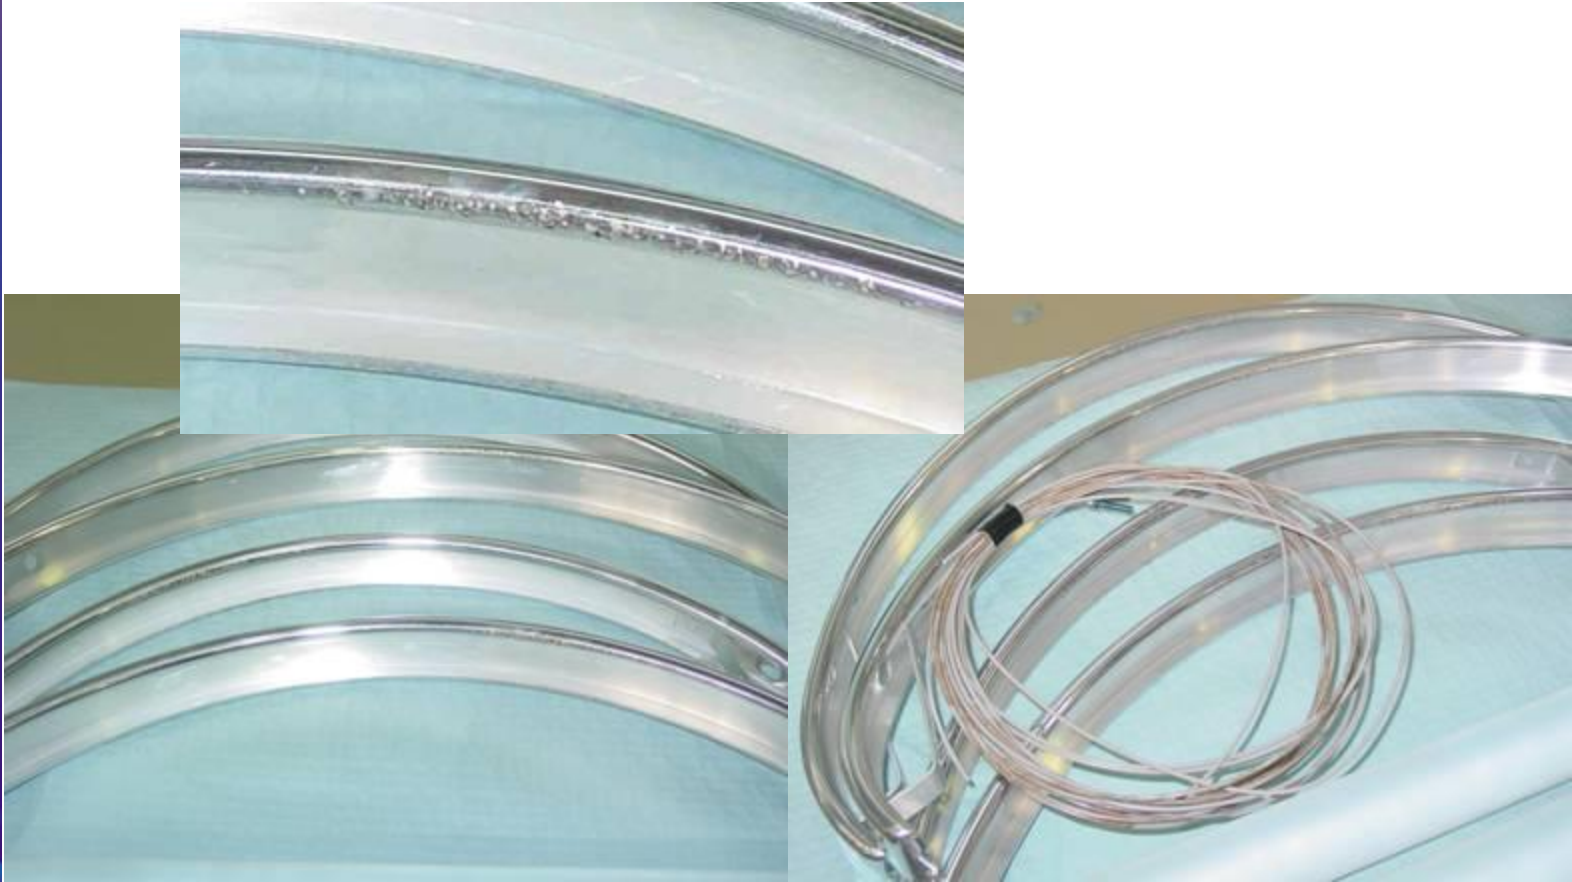
- Another Inspection of the internals of the accelerator revealed damage by the fibre optics lying along the equal potential rings.

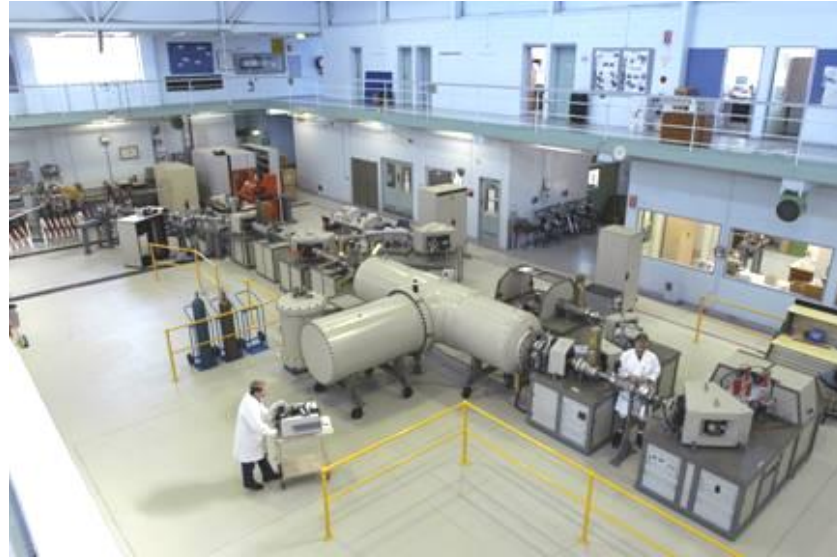
- The purity of the gas was questioned as was the possibility of a leak of an Argon leak from the stripper supply.

- In an attempt to increase insulation, the SF6 gas pressure was increased from 6 bar to 7 bar.

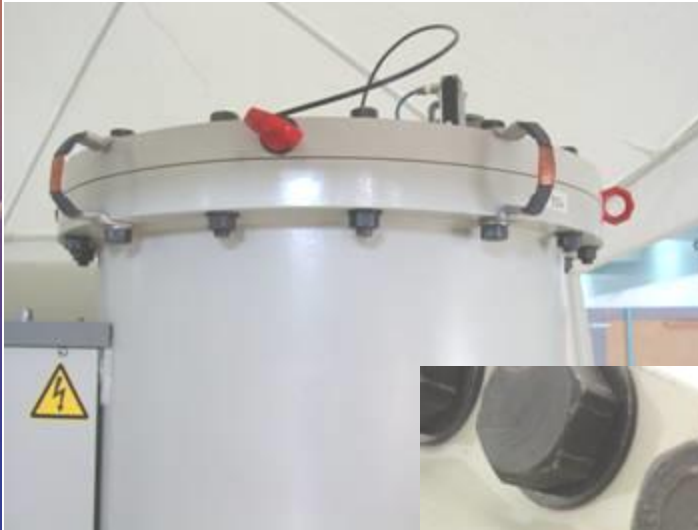
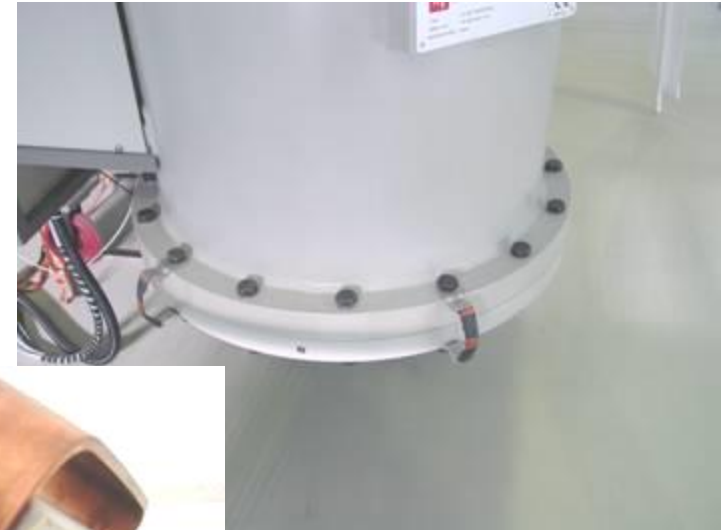
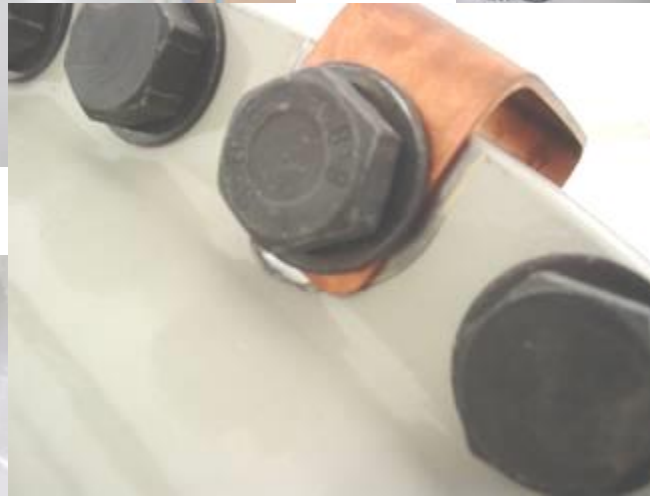
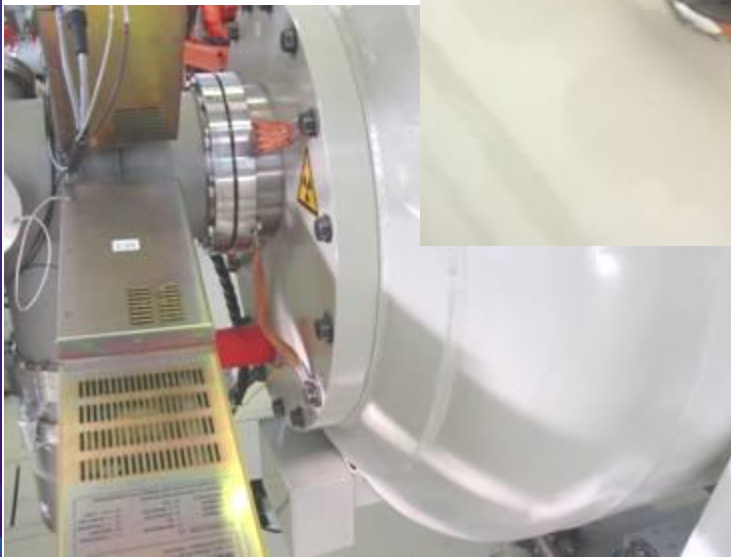
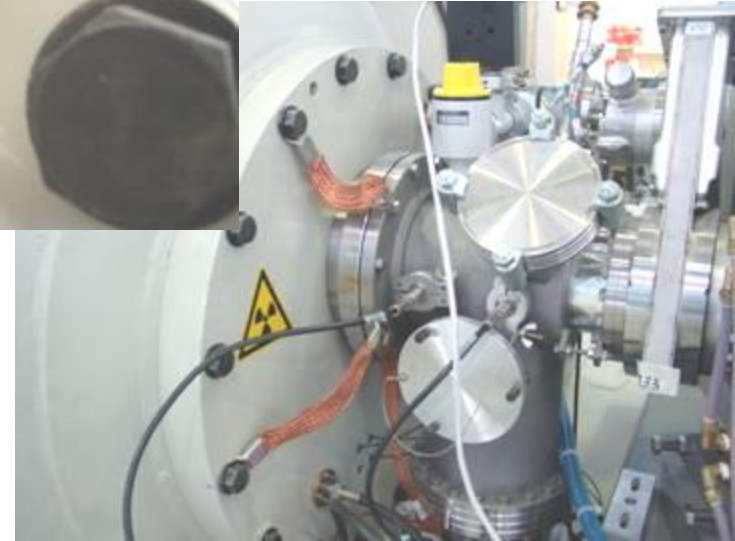
1. There were witness marks across some of the flanges from discharges.
2. The upper and lower copper skin plates in the coil housing had been assembled the wrong way around.
